Section 3. Outstanding Projects of 2005

Stibnite Mine Restoration: Glory Hole and Meadow Creek Projects

South Fork Cottonwood Creek Watershed Enhancement Project – Phase I

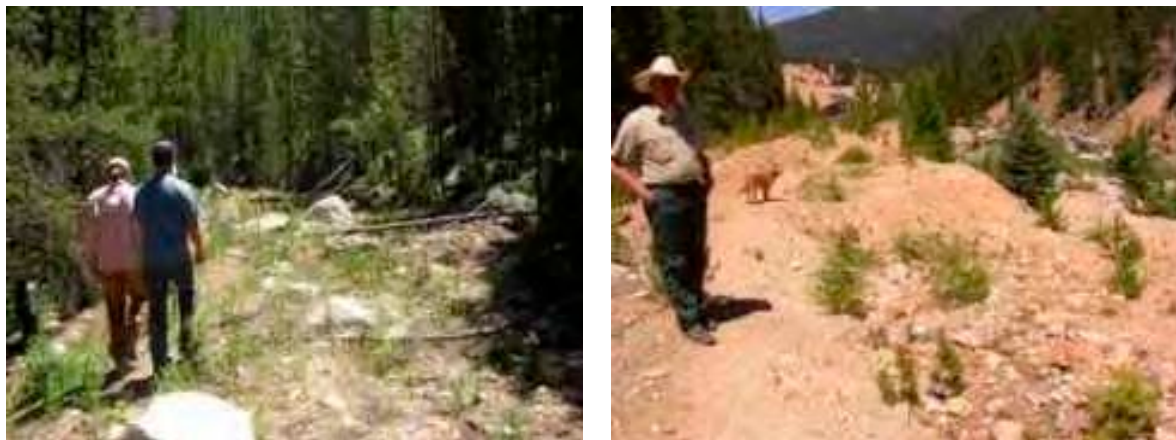
The only access to the Monday Camp was the cause of significant stream bank instability, responsible for production and delivery of in excess of five (5) tons of sediment per year (Figure 3).

Figure 3. Approximately 1.5 miles of access road to the Monday Camp Dump was redeveloped for access to the project. The historic roadway was marred by massive slope failures and deeply incised gullies on fill slopes. The road represented a major eroded surface and source for fine sediment delivery.

At the conclusion of the Monday Camp Dump stabilization task, the road was obliterated. Because riparian vegetation had established along the river, fill slopes were not pulled back and re-graded against the cut banks, but approximately two (2) acres of road surface were scalloped, using a track hoe, and then treated with fertilizer and reseeded. In areas where runoff waters eroded deep gullies, the watercourse was deeply ripped and armored with coarse durable rock. Finally, the entrance to the access road was filled with 36" (and larger) boulders to prevent ATVs from traveling on the reclaimed area.

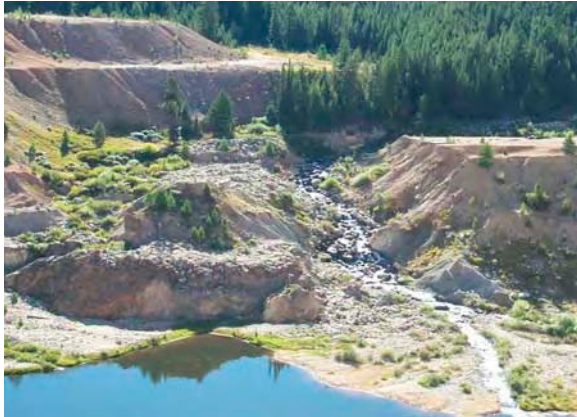
The East Fork of the South Fork of the Salmon River flowed alongside and undercut over 500 linear feet of the toe of the Monday Camp Dump (Figure 4), contributing approximately 500 tons of what was presumed to be heavy-metals-laden sediment to the delta beneath the cascade. With no opportunities to relocate the channel, the solution was to *lay back* the entire dump (Figure 5), stabilizing it by soils building and revegetation.

Figure 4. The river cuts through toe of the Monday Camp dump.

Stream banks were initially excavated to expose materials for testing of hazardous materials and heavy metals and to create a working platform. A long reach track hoe was used to selectively pull back mine wastes and leave established riparian plants.

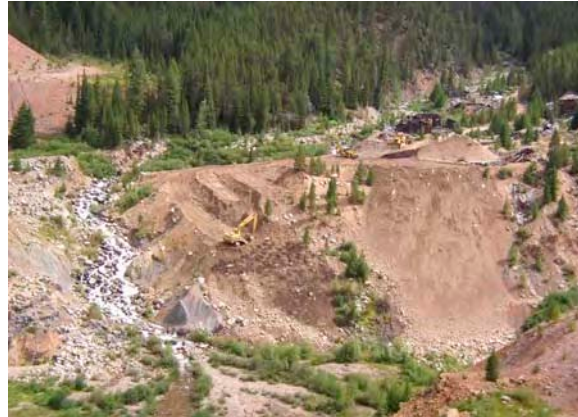
Figure 5. Monday Camp Waste Dump during stabilization task. Note the track hoe near the center of the picture.

Fifty thousand (50,000) tons of mine waste was removed from the dump face and placed on another angle of repose dump face with approximately two acres of vegetated buffer area (Figure 6). The location and the underlying buffer zone ensure that fines eroded and transported down-gradient will be captured and attenuated. Once the mine waste had been removed, the dump was re-graded and scalloped using the track hoe.

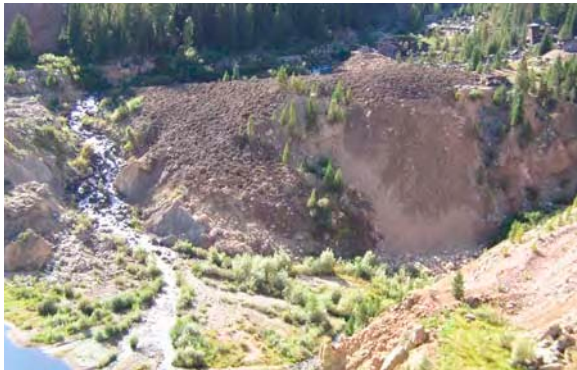
Figure 6 Stabilized Monday Camp Dump.

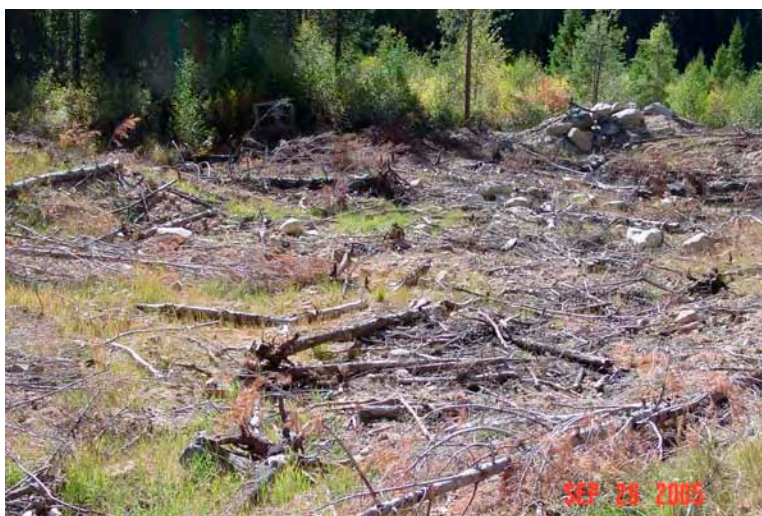
Figure 7. Reclaimed sediment basin alongside of Glory Hole and the public access road was constructed from a top soil borrow source that was developed for the reclamation work in the Meadow Creek Valley.

After the top soil was removed from the borrow pits, DEQ had its contractor divert the drainage along the county road and the toe of the Northwest Bradley Waste Dump area into three borrow pits and a mine bench that were over-excavated to produce sediment basins. These basins were then roughed up, treated with top soil amendments, and planted with native seed mixtures (Figure 7).

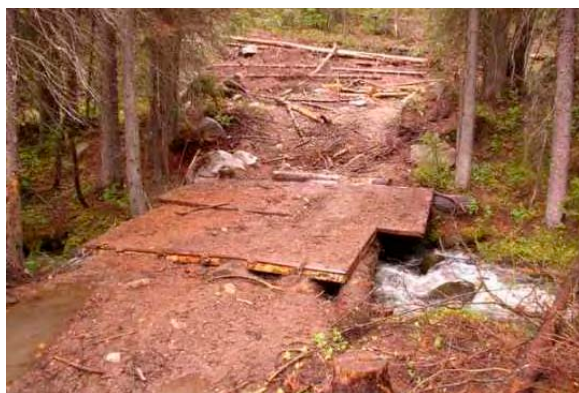
Figure 8. Bradley Property Timber Project temporary stream crossing prior to reclamation work done under the Glory Hole CWA section 319 Project.

Although a timber project was contracted by the Bradley Mining Company and regulated by the Idaho Department of Lands, the operator failed to fully reclaim the project area. Seizing an opportunity to acquire additional raw materials, DEQ and Thornton Construction salvaged slash and top soil, removed a poorly constructed stream crossing (Figure 8), and completed some of the timber company's reclamation work. When completed, DEQ reclaimed approximately 200' of timber roads and a one-acre area of disturbed lands that had been used to stockpile slash and logs.

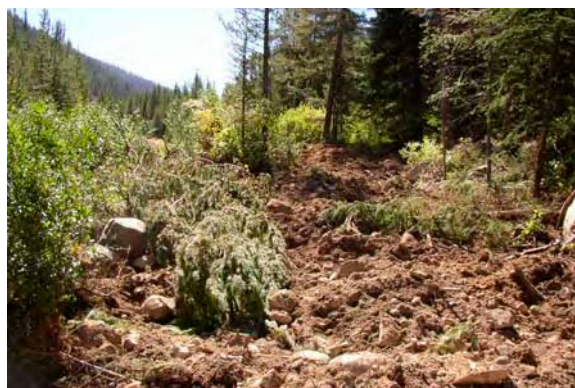
Figure 9. Obliterated Monday Camp Access Road after reclamation of the Monday Camp Dump.

Approximately 200 tons of large woody debris and 1,000 cubic yards of top soil were removed from the timber project area (Figure 9). The top soil had apparently been stockpiled during historic mining activities and was not discovered until Thornton construction began reclamation of the timber project. This large woody debris was stockpiled at the Meadow Creek Project site pending its use on constructing vegetated islands and general scatter.

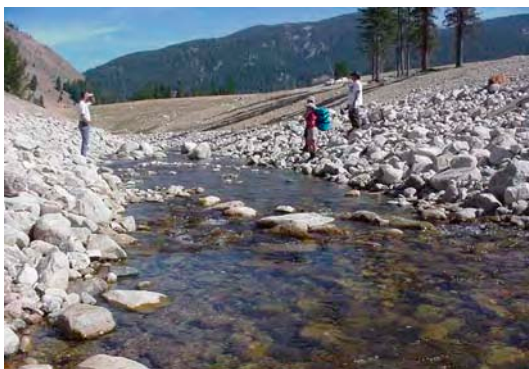
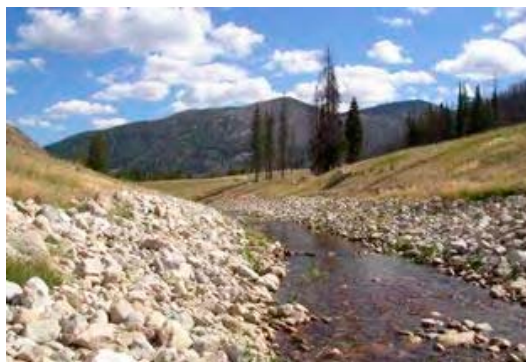
Prior to DEQ's projects, which began in 2003, very little vegetation had begun to establish itself along the stream bank (Figure 10, left). In 2003, volunteers made up of Boy Scouts, high school students and teachers, DEQ and Fish and Game employees, and a local outfitter started planting willow cuttings, and one-year starts of riparian species. Volunteers also helped broadcast native seed mixtures along the channel.

Figure 10. (Left) Meadow Creek Stream prior to 2003 plantings. (Right) September 2005, after plantings.

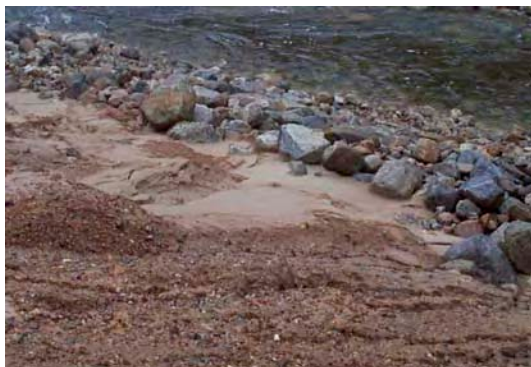
Figure 11. (Left) Poorly implemented BMPs prior to this project resulted in continued piping of heavy-metals-laden tailings. (Right) Top soil backfilling and revegetation stabilized the springs, reduced flows, and curtailed delivery of tailings.

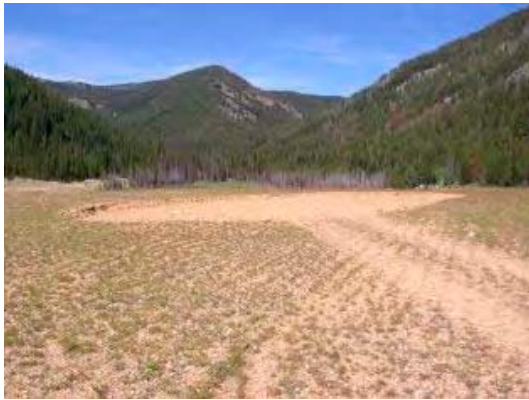
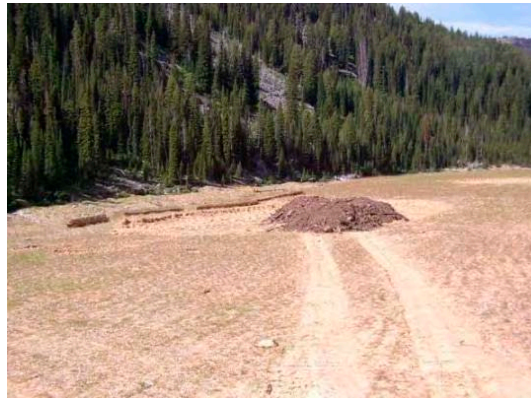
Figure 12. Islands were over-excavated one foot below the original surface and then backfilled with a mixture of spent ore, top soil, and compost to an average of one foot above the original surface.

Initially, it was believed that DEQ's project would not generate enough top soil and amendments to cap the *spent ore disposal area* (SODA). Consequently, DEQ decided to try the longer-term solution of creating productive islands of vegetation from which seed and organic debris would be generated in sufficient quantities to slowly cover and re-colonize the SODA (Figure 12-Figure 14).

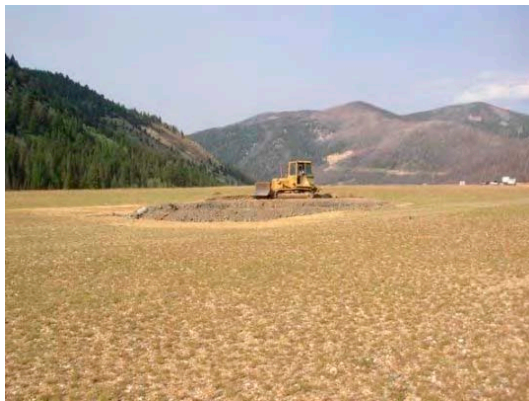
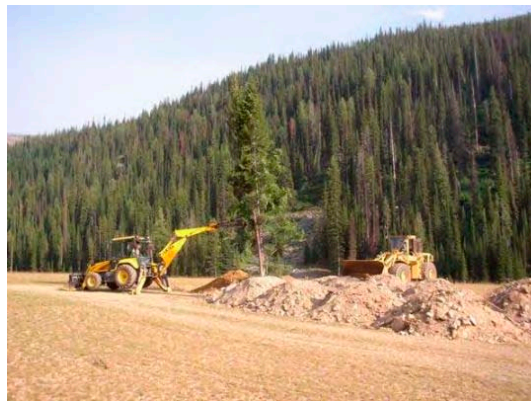
Figure 13. The placement of the backfill mixture created an absorbent island of growing material that would capture and retain surface runoff from the interior of the SODA until the moisture could be evapotranspired, significantly reducing surface runoff that had previously caused most of the erosion on the SODA benches.

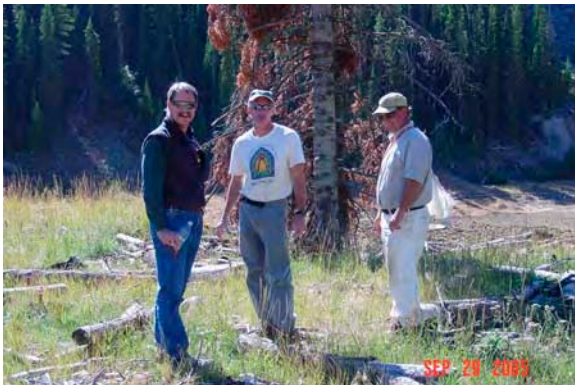
Figure 14. One year after creating the first vegetated islands, lush grassy species and large woody debris hide and shade over 9,000 plantlings of wild roses and lodge pole pines.

In total, for the 2004 and 2005 construction seasons, nine (9) islands, each of which are approximately a quarter-acre in size, were constructed. After one year, the first vegetated islands produced lush vegetation and acted like sponges to hold soil moisture content above ten per cent until mid September.

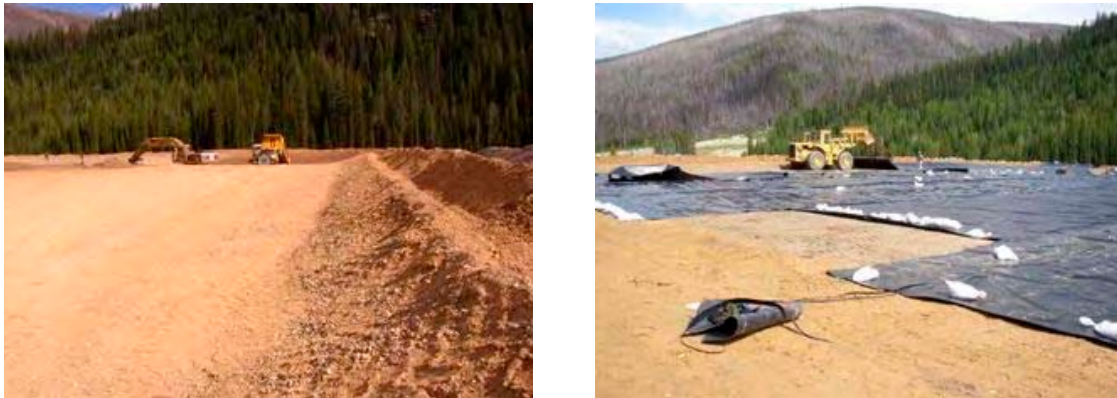
Construction began with excavating spent ore from an area approximately 175 feet by 275 feet (Figure 15). The excavation provided for a 150-foot by 150-foot surface that had a 0.5 percent grade towards a 400,000 gallon settling basin. The pond was designed to contain 48 inches of precipitation that may occur in winter, to prevent runoff from the compost into the nearby Meadow Creek.

Figure 15. (Left) Excavated spent ore from storm water ponds and placed as berm. (Right) HDPE liner is placed on compacted tailings above repository.

Approximately 600 cubic yards of excavated spent ore was placed around the whole area as a retention berm. The interior of the composting area and retention pond was then backfilled with tailings to create a subliner approximately one (1) foot thick prior to placement of a 60-mil high-density polyethylene liner and geotextile.

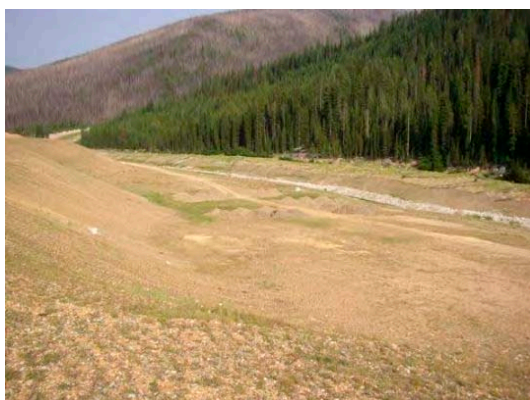
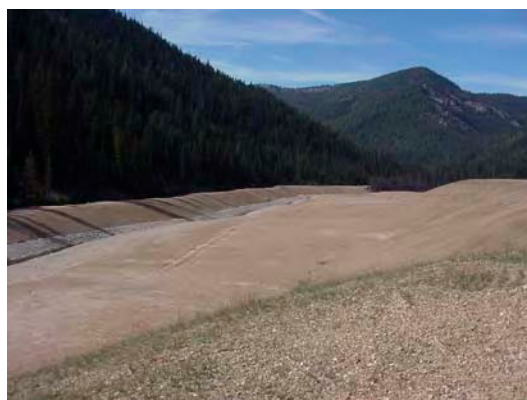
The SODA's topography is dominated by two benches that adjoin Meadow Creek. Similar to geologic contact zones, the zone between these benches is a conduit for near surface ground water flow. In several locations, the flow is expressed at the surface as springs, the most notable of which is a five (5) acre area (Figure 16). Until 2004, the areas around these springs were completely devoid of vegetation, and, were sources for the production and delivery of an estimated five (5) tons of metal-bearing fine sediment to Meadow Creek.

Figure 16. Springs are present at the base of the upper SODA bench (left), which became the site for a five acre wetland development to contain and abate fine sediment production and delivery to the adjoining Meadow Creek channel (right).

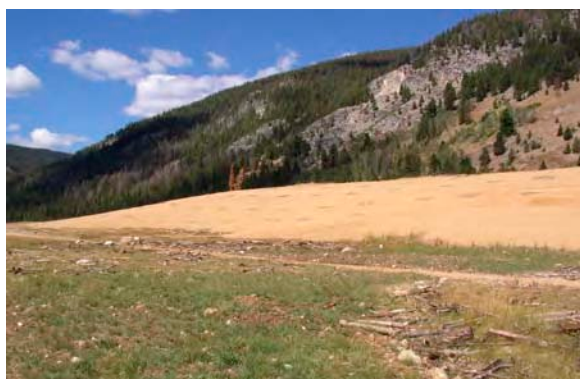
Figure 17. One year after seeding, approximately fifty per cent of the upland and riparian plantings died from drought and browsing by deer and elk. However, lush grassy species development now hides and shades the remaining plantlings.

In 2004, DEQ and its contractor, Thornton Construction, began to develop these springs into functional wetlands, which would capture storm water runoff and the fine sediment it transported rather than acting as a source. With substantial soil amendments, these areas are already functioning to capture and attenuate sediment from the SODA (Figure 17).

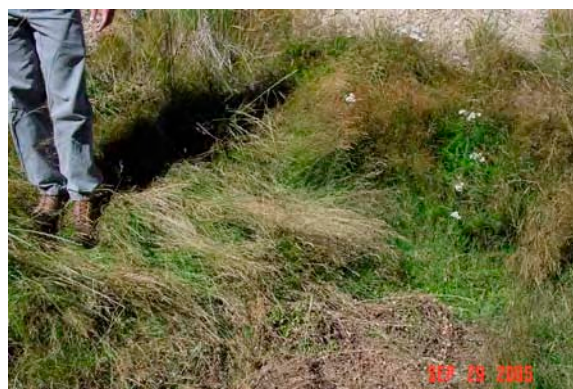
Figure 18. One year after planting, thick growths of grasses and forbs hide ten-inch willow, alder, and aspen starts.

Several different surface expressions of the springs were planted to contain stratified vegetative communities (Figure 18). Plantings provided for a slight overlap between each community. In the center of the wetlands, where there is a continuous presence of water, cattails and rushes were planted. From just inside the peripheral edges of the cattails and rushes, to the ephemeral edges of the spring, a mixture of alders, willows, dogwoods, wild roses, and quaking aspen were planted. Lastly, lodgepole pines were planted in uplands areas that tended to dry out before August of each year.

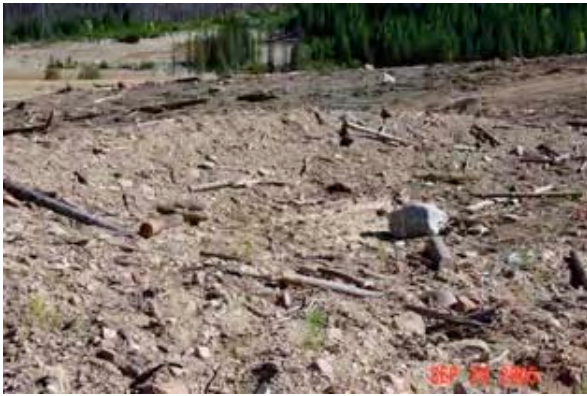
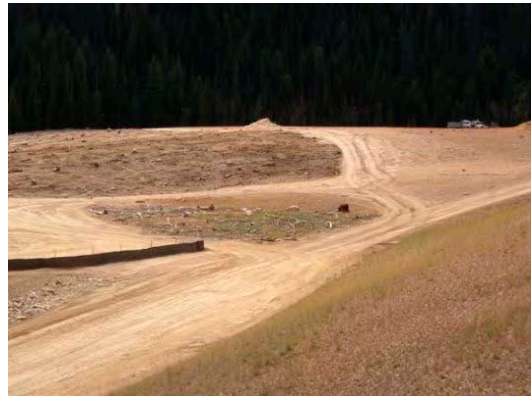
Figure 19. Additional wetland sites were developed on slopes where other springs expressed themselves or where annual surface runoff could be retained by placing top soil in a way that created a dam and sediment basin. The dams were planted with upland species while the bottoms of the sediment basins were planted with wetland and riparian species.

Approximately three (3) more acres on the SODA were determined to be suitable for wetland development (Figure 19).

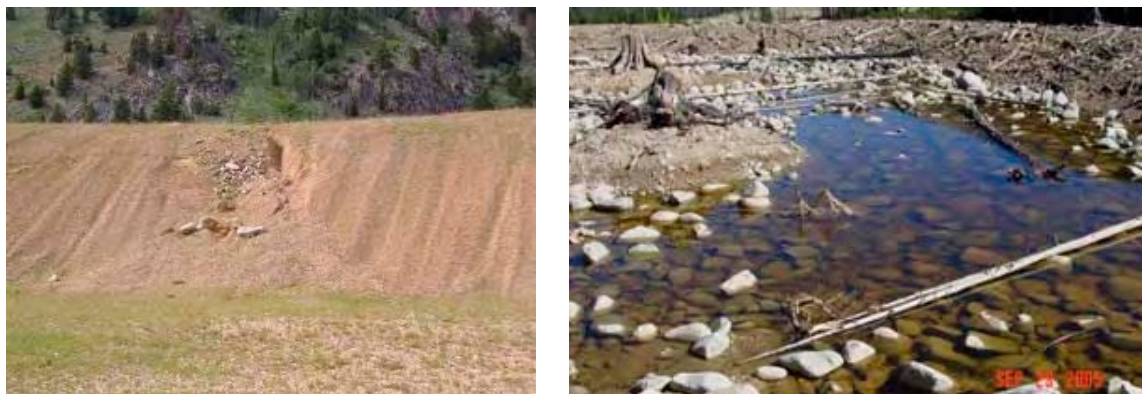
Figure 20. (Left) Surface runoff and mass wasting of upper SODA bench is one of the more significant sources for fine sediment production and delivery. (Right) The storm water catchment pond at the composting facility was developed as a wetland to continue to restrict surface water runoff and utilize it to develop a vegetative cover on top of the SODA.

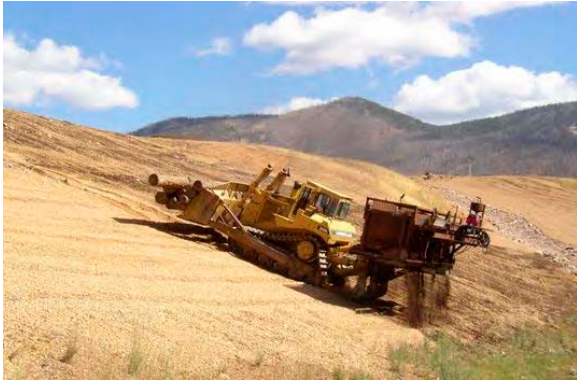
Figure 21. D-8 Caterpillar with apron feed compost spreader applies approximately 0.25 inches (1,800 lbs/acre) of compost to the surface of the re-contoured upper SODA bench. Subsequently a D-3 Caterpillar dozer cross-ripps the bench parallel to the contours to impede overland flows.

It was determined, therefore, that Thornton Construction should lay the slopes back and treat the slopes with approximately 1,800 pounds of compost per acre, constructing more than 250 micro islands, and planting 120 trees and shrubs in those micro islands (Figure 21). The total area treated in this fashion was approximately 2,000 feet long and 300 feet wide (15 acres).

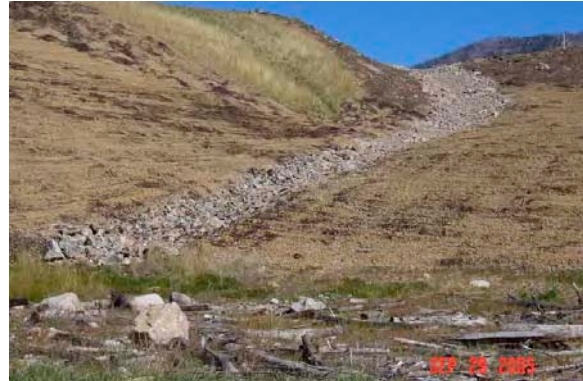
Figure 22. Constructed armored drain connects wetlands constructed at the composting storm water pond to the wetlands constructed on the lower bench of the SODA

DEQ designed and constructed armored drains on the SODA (Figure 22) to convey high flows during spring and storm runoff through a series of sediment basins and wetlands, eliminating annual delivery of approximately five (5) tons of metal-laden sediment from the top of the SODA into Meadow Creek. The drains also decrease the amount of water percolating into the SODA and the subsequent leaching of dissolved metals, and they conserve and direct fresh water into the constructed wetlands and vegetated islands.

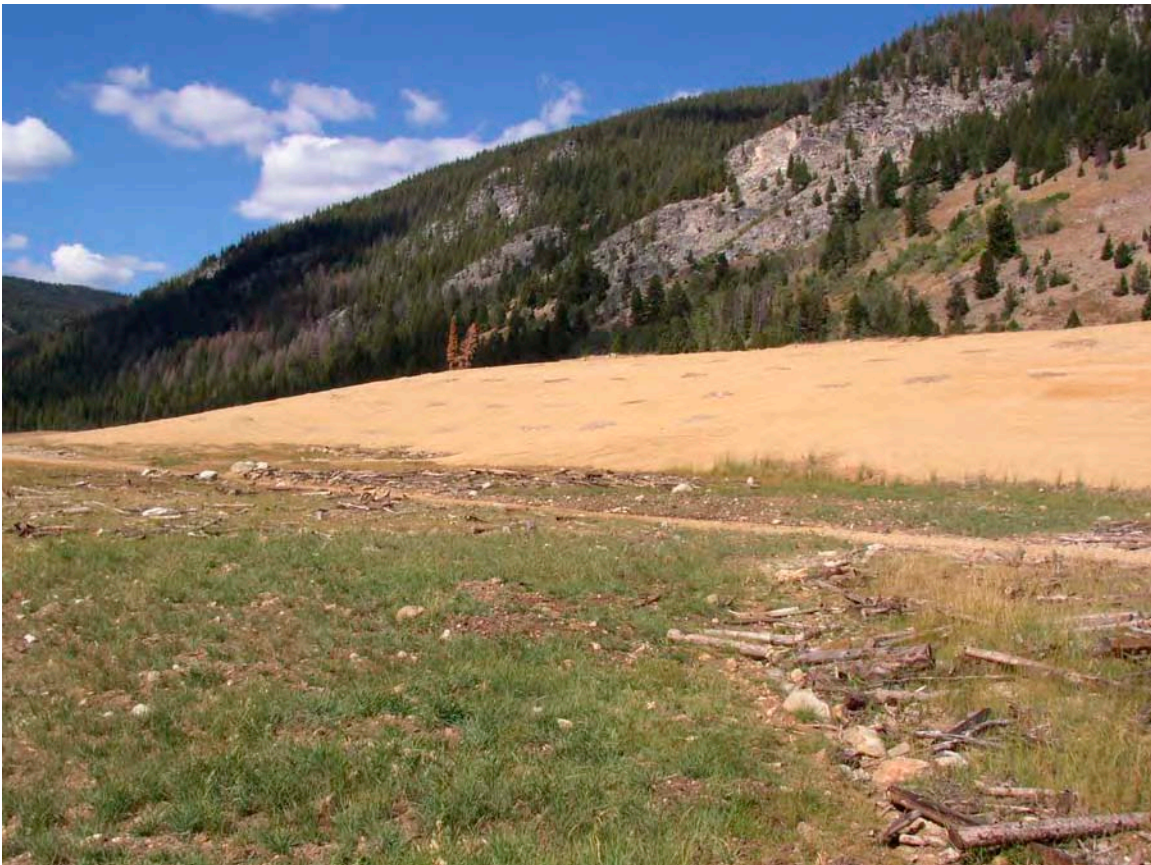
Figure 23. Micro-islands were constructed on the re-contoured and composted upper SODA bench slope, spaced at approximately 50-foot centers. The micro-islands were constructed by excavating three cubic yards of spent ore, mixing it with two cubic yards of top soil and compost, and then backfilling the excavation. The micro-islands were then seeded and planted with lodgepole pines and wild roses.

Prior to reseeding the slopes of the upper SODA bench, Thornton Construction dotted the landscapes with micro-islands (Figure 23). Thornton excavated approximately three (3) cubic yards of spent ore and replaced it with topsoil and compost in each of the micro-islands. DEQ then seeded the entire slope and planted four to six ten-inch starts of ponderosa pine and wild roses in each. It is hoped that the lush vegetation that develops on each of these micro-islands will provide long-term seed sources for trees and shrubs and slowly expand outward across the slope.

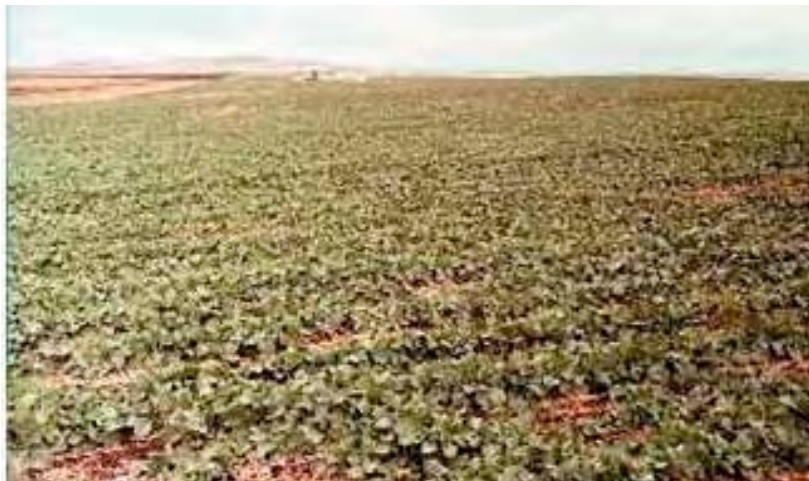
Figure 26. Direct Seed reduces runoff and sediment losses from fields due to the amount of residue left on the surface. In the Cottonwood area, there is approximately 10 tons/acre/year of sediment reductions due to direct seed and no-till systems.

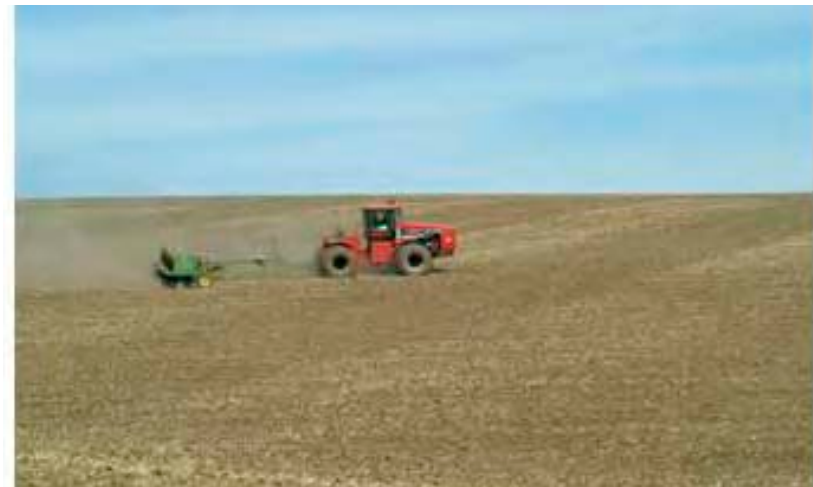
Figure 27. Residue remaining in this minimum tillage field is significantly lower than residue rates in direct seed systems. The additional residue in direct seed systems slows runoff waters allowing infiltration into the soil and lowers sediment losses from the fields.

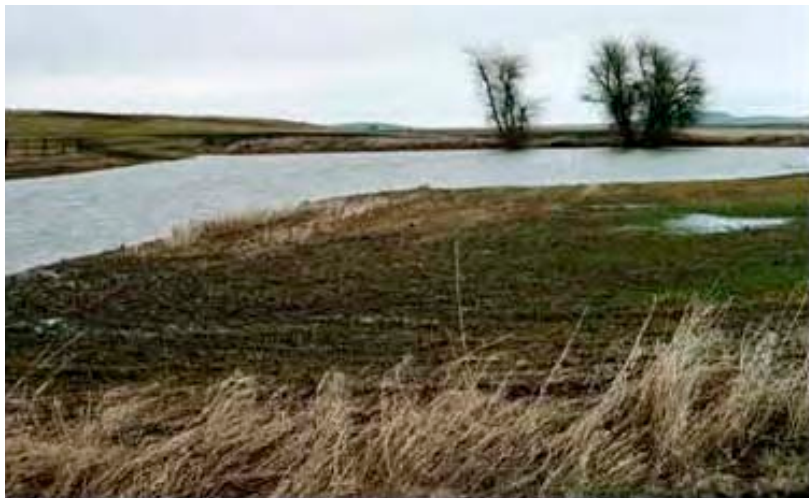
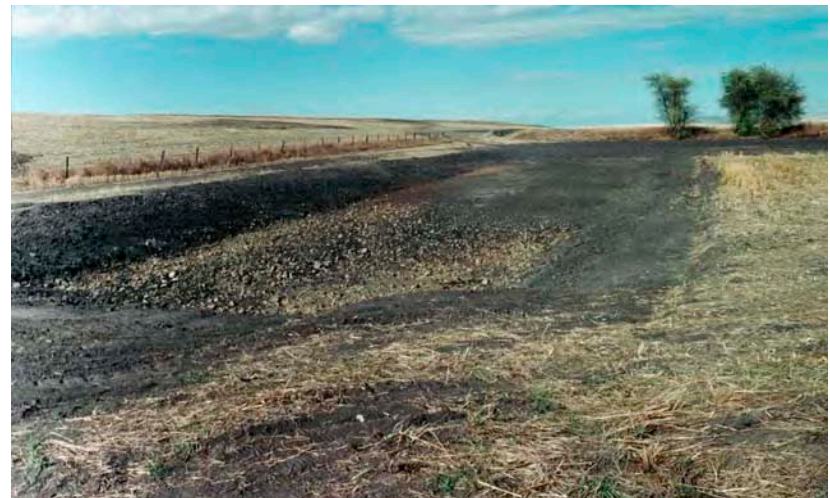
Figure 28. Sediment basins collect sediments and reduce the amount of sediment and nutrients entering streams and other water bodies. This sediment basin is seen completed in the fall (right) and full of water and sediments in the spring (left).

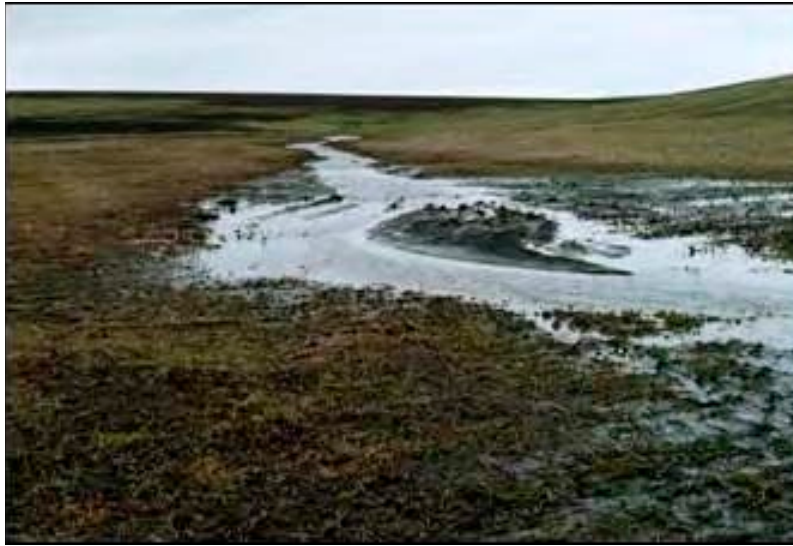
Figure 29. The runoff depicted is typical of summer fallow systems in the Cottonwood area before cooperators converted to direct seed systems. In areas where landowners are not converting to direct seed, some landowners are installing sediment basins to collect sediments.

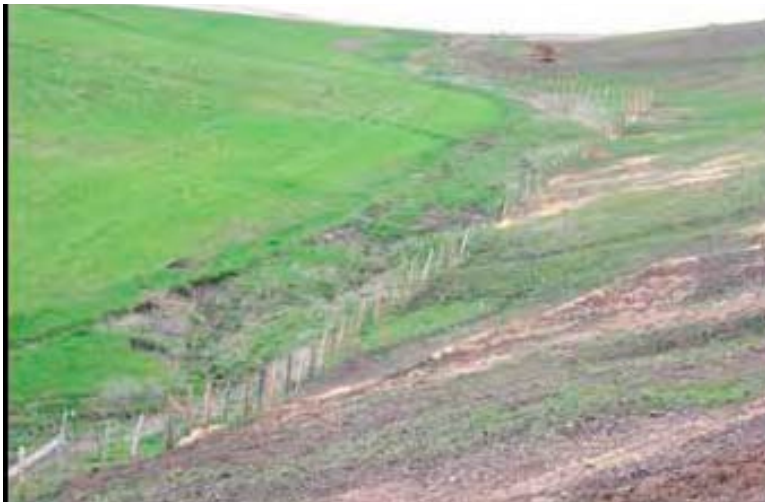
Figure 31. Fencing (left) reduces impacts to stream banks, and direct access to live water allowing streams to recover and pollutant loads to be reduced. The green re-growth along the creek in this photo is one season of re-growth.

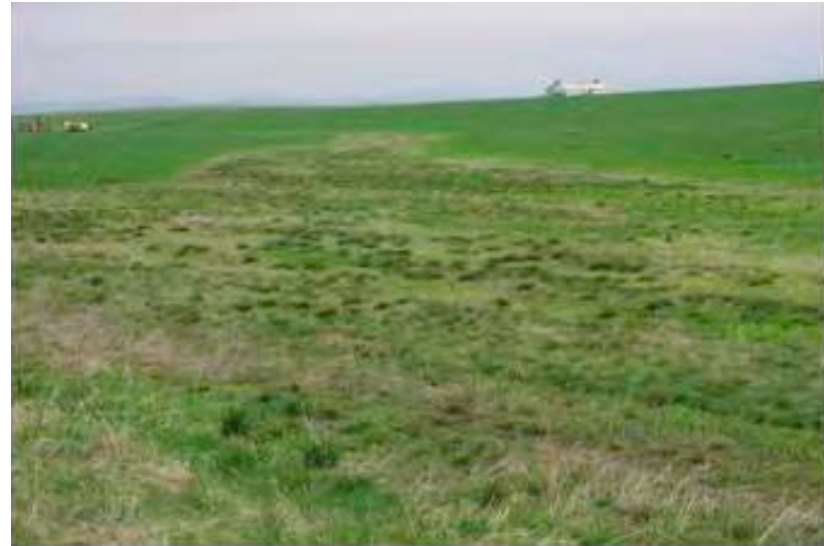
Figure 30. Filter strips, serve to reduce sediment, bacteria, and nutrients entering water bodies. This is accomplished by slowing water velocity, allowing contaminants to settle out of run-off waters.

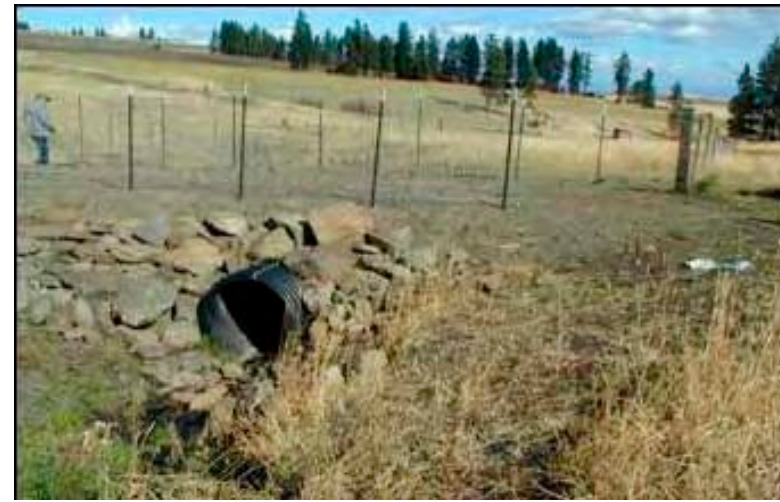
Figure 32. Culvert crossings provide livestock access to additional pasture areas with minimal impacts to stream banks and creek waters.

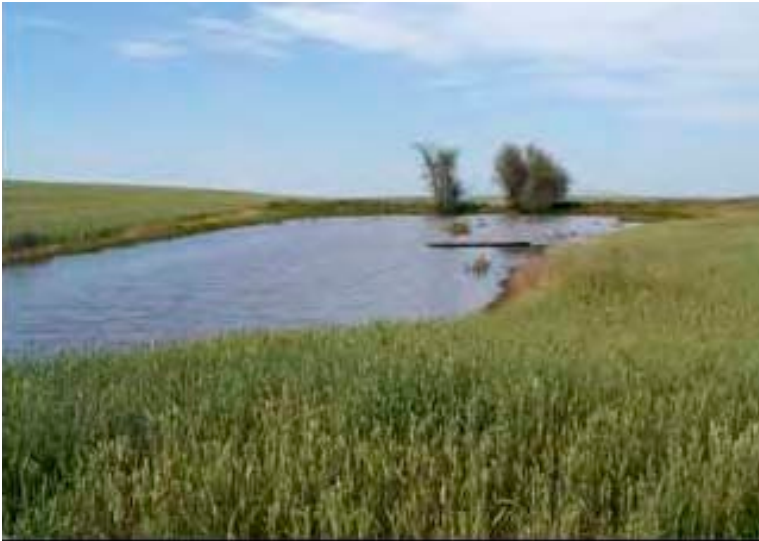
Figure 33. Sediment Basin two years after installation. Fifteen tons of sediment has been removed each year from this basin.

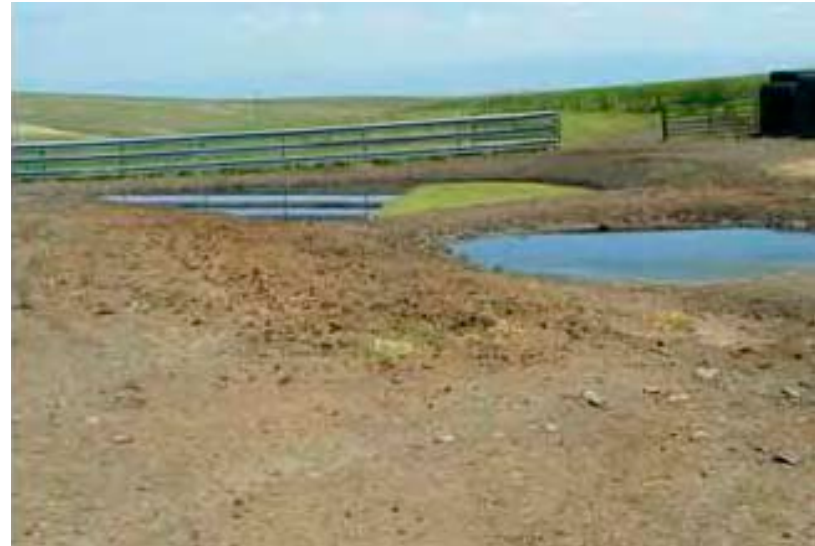
Figure 34. Corral berms help to contain corral water and manure, allowing pollutants to settle and keeping them from entering the creek.
